# **NATIONAL TRANSPORTATION SAFETY BOARD**

## **HIGHWAY ACCIDENT REPORTS**

**SUMMARY FORMAT  
ISSUE NUMBER 1 -- 1980**

NTSB-HAB-80-3

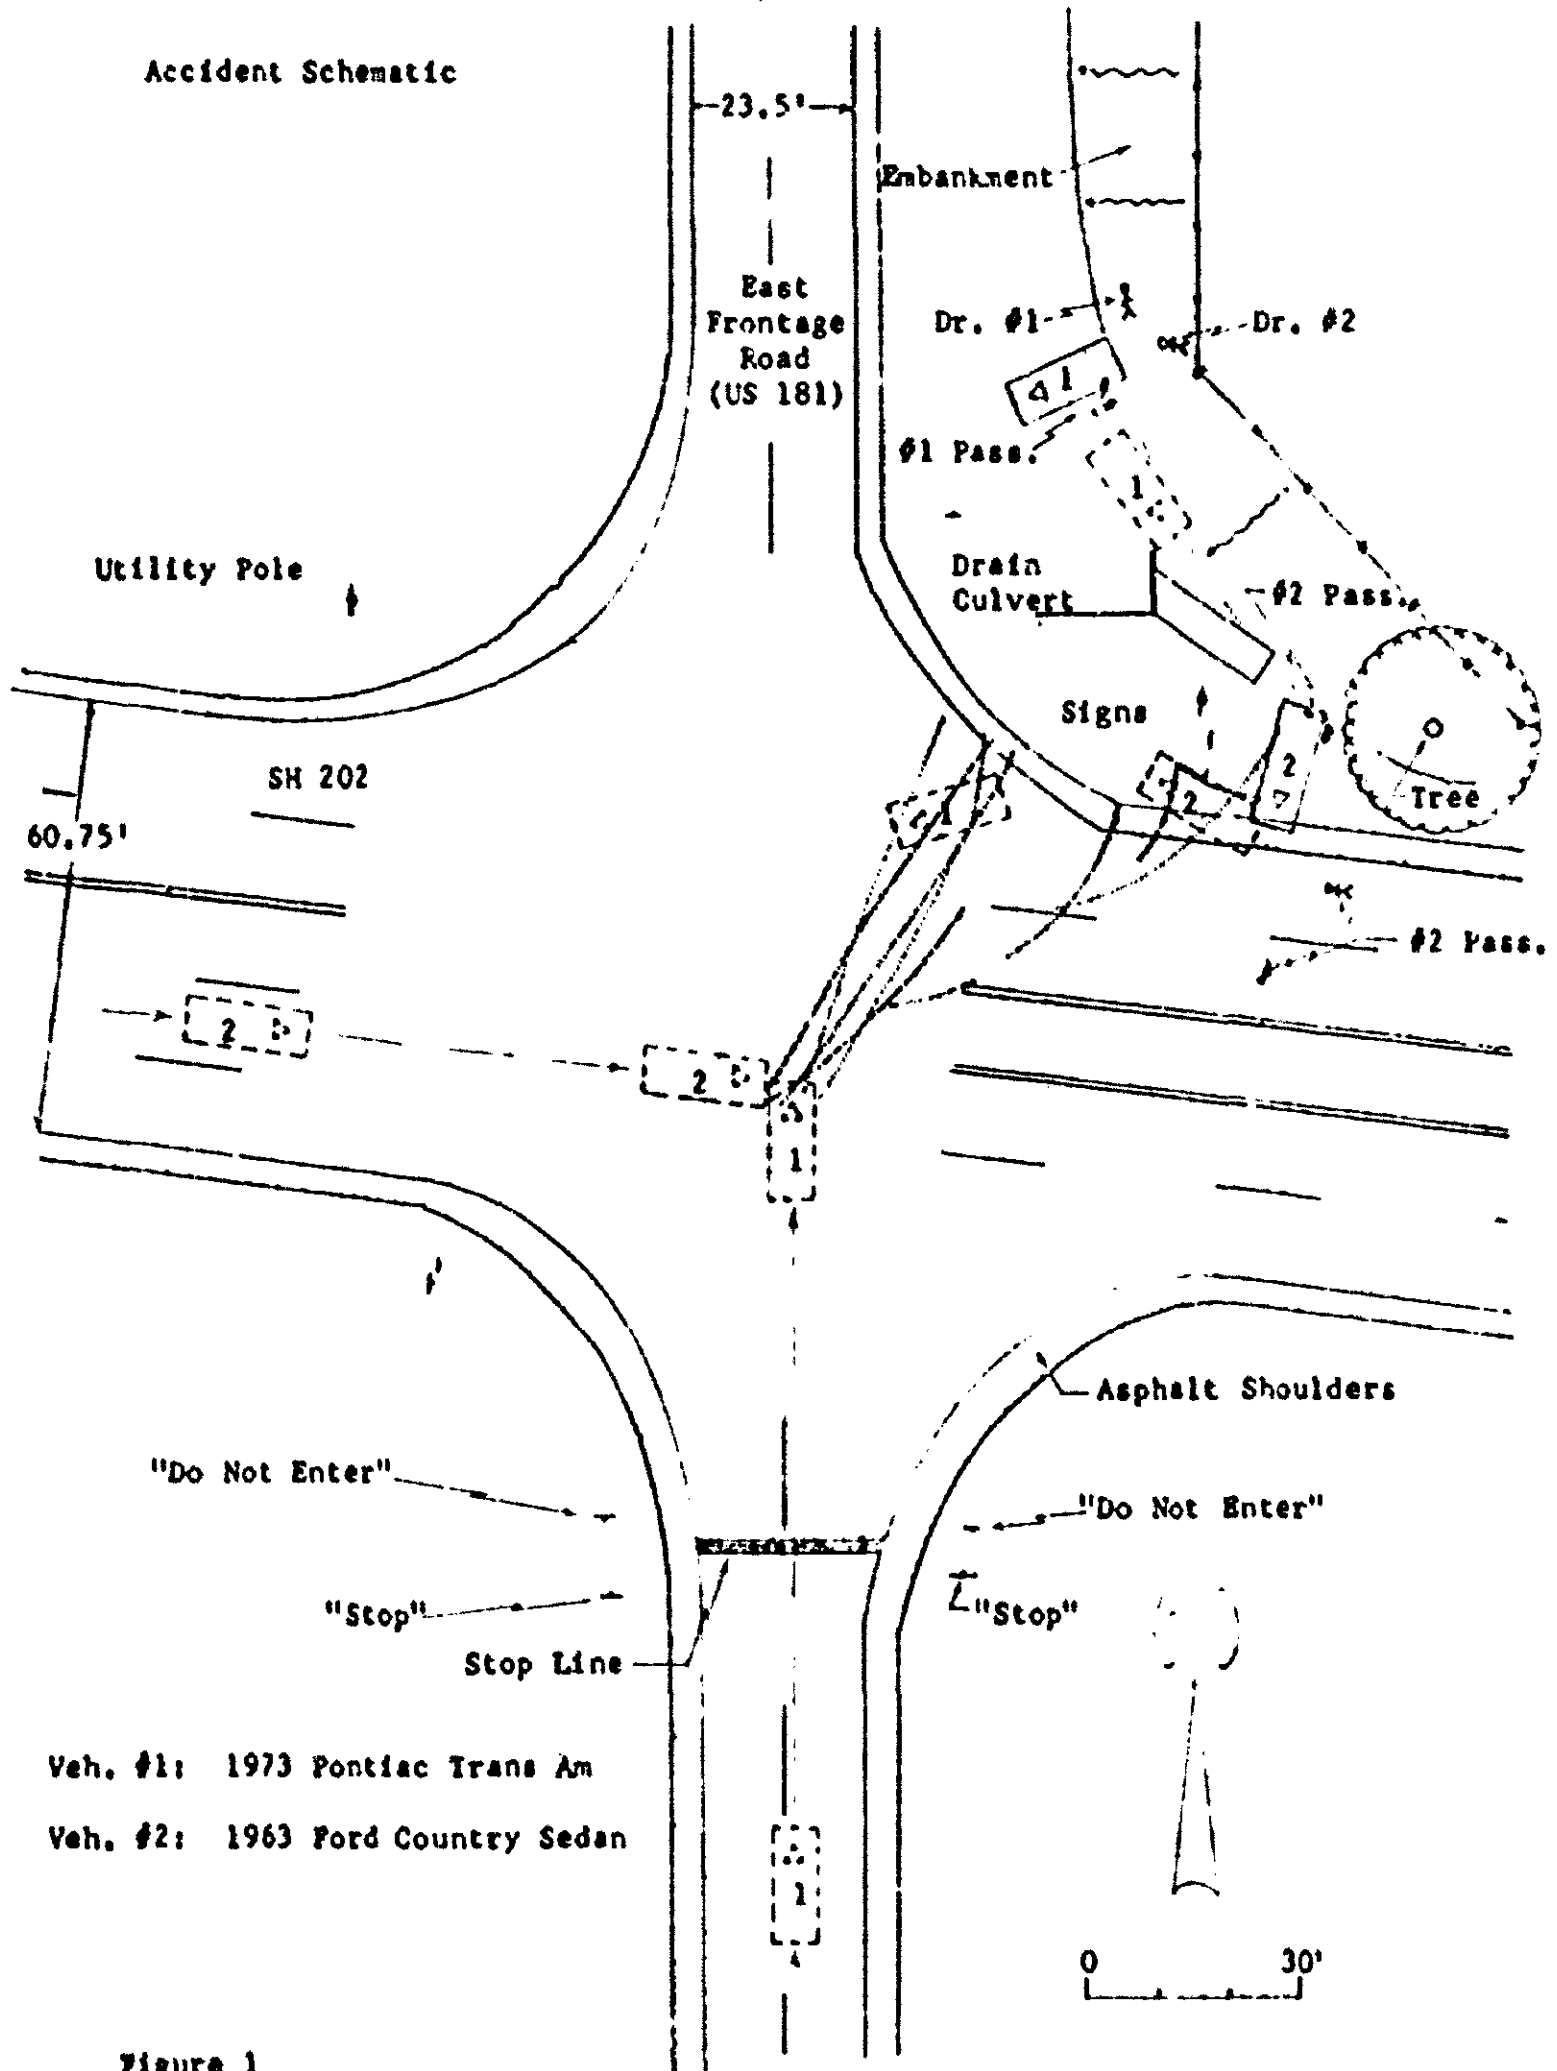
Figure 1

Accident Schematic

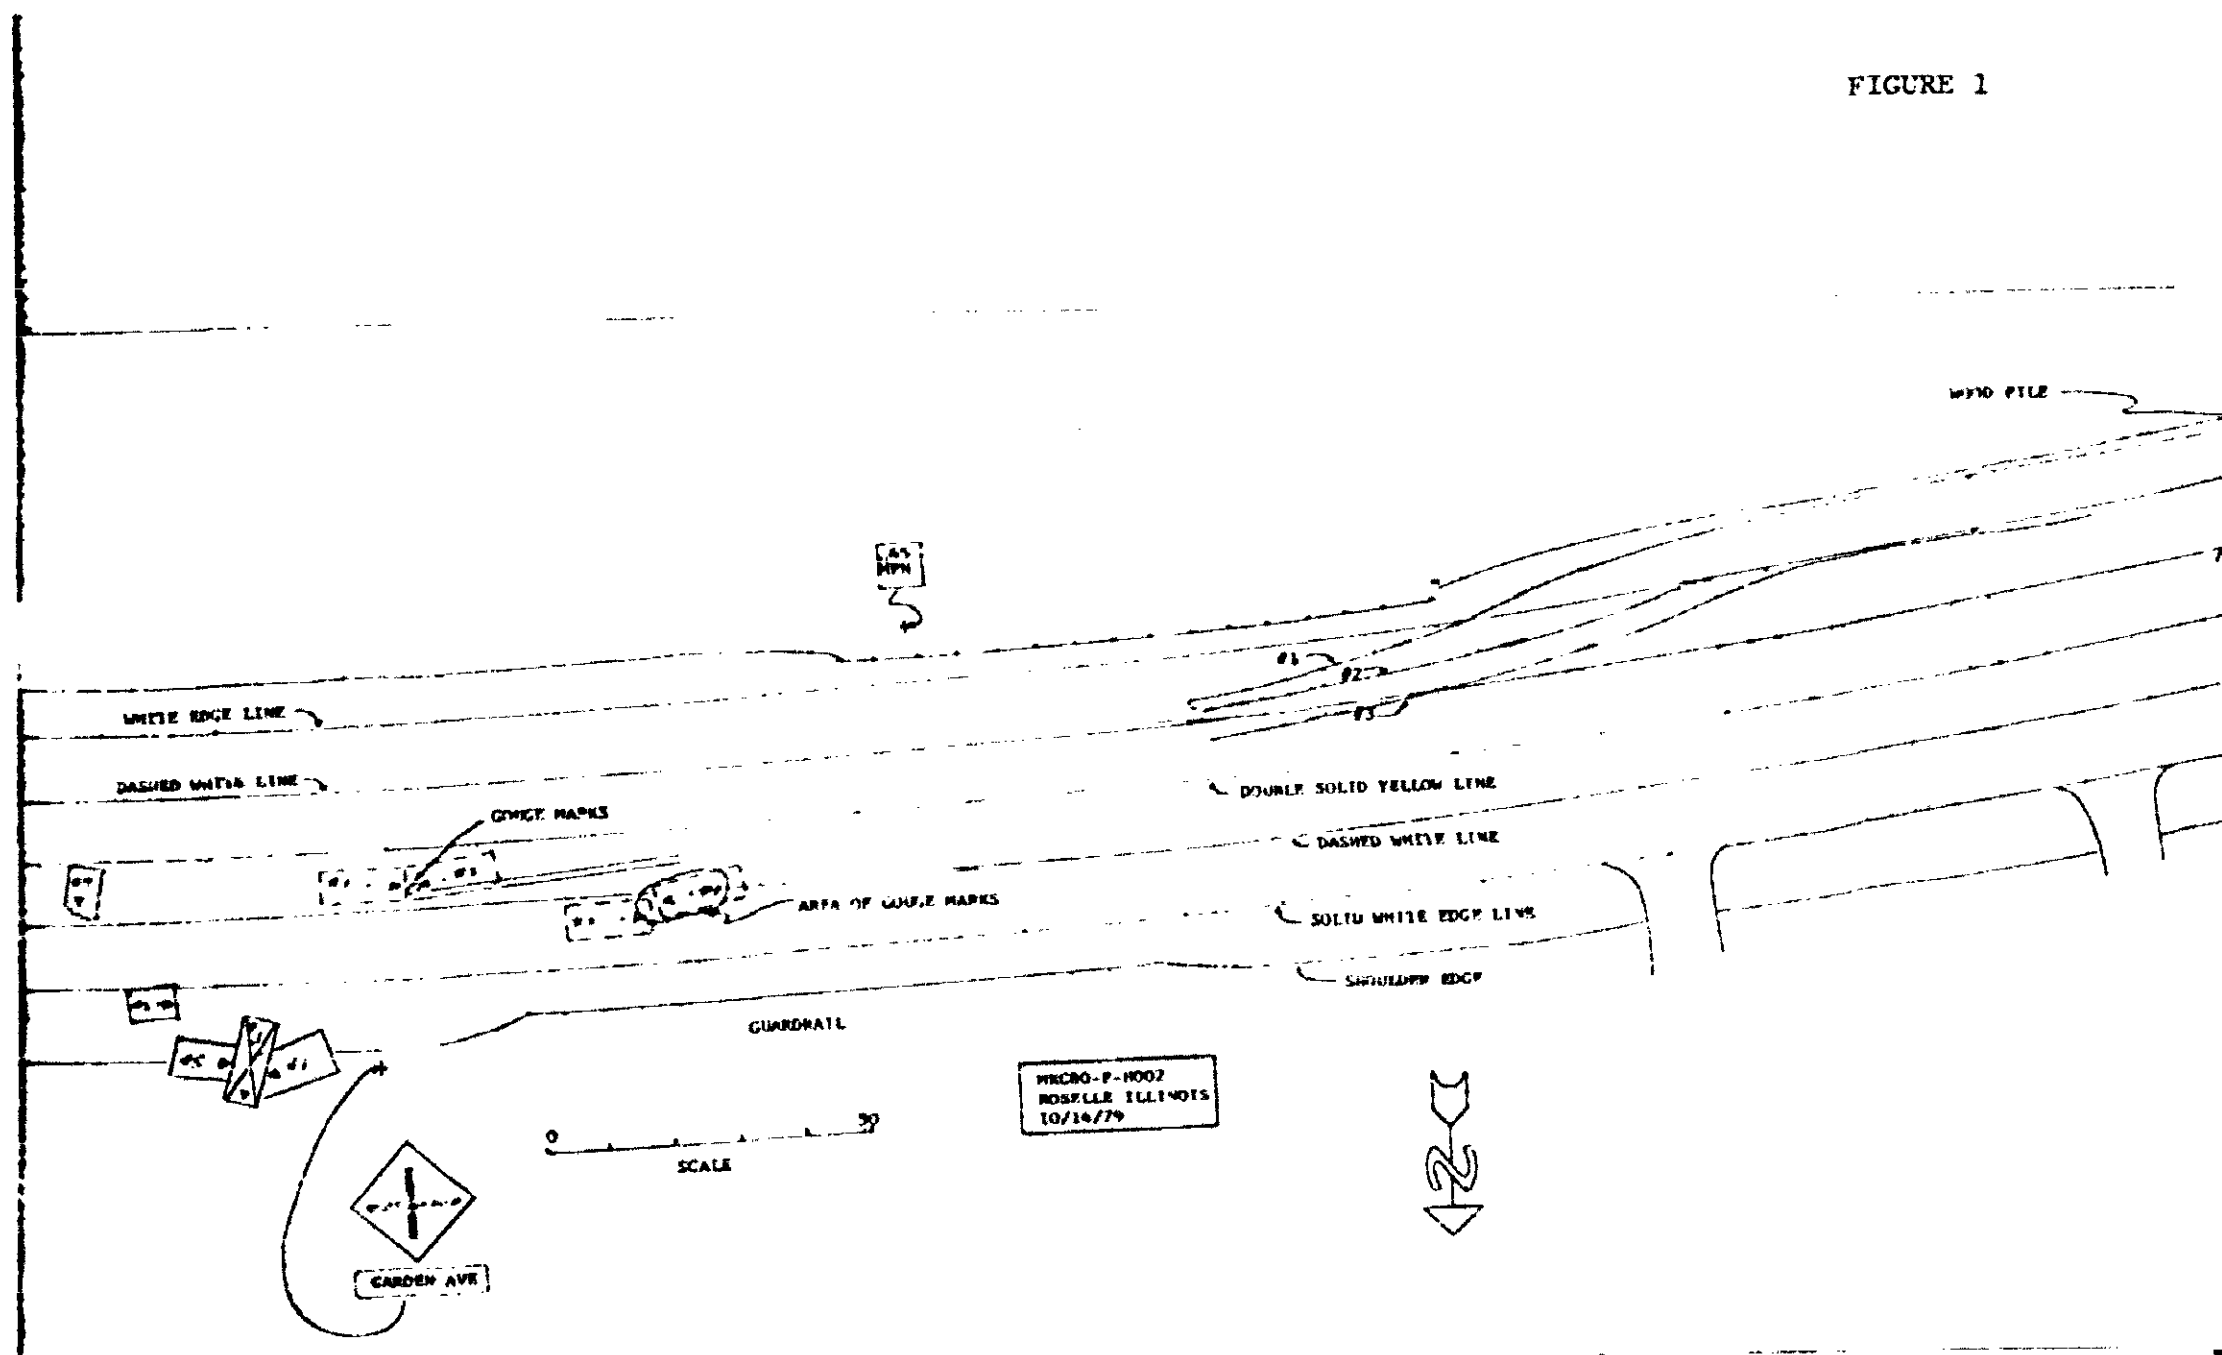
FIGURE 1

Almost simultaneously, the Cadillac struck a westbound 1973 Pontiac headon in the outside lane, and the Chevrolet struck a westbound 1975 Oldsmobile, also headon, in the inside lane. The Cadillac continued eastward, propelling the Pontiac to the shoulder of the westbound lanes. When they stopped, the Pontiac toppled over, landing on the hood of a fifth car, a westbound 1977 Chevrolet which had pulled to the shoulder and stopped to avoid the observed accident. (See Figure 1)

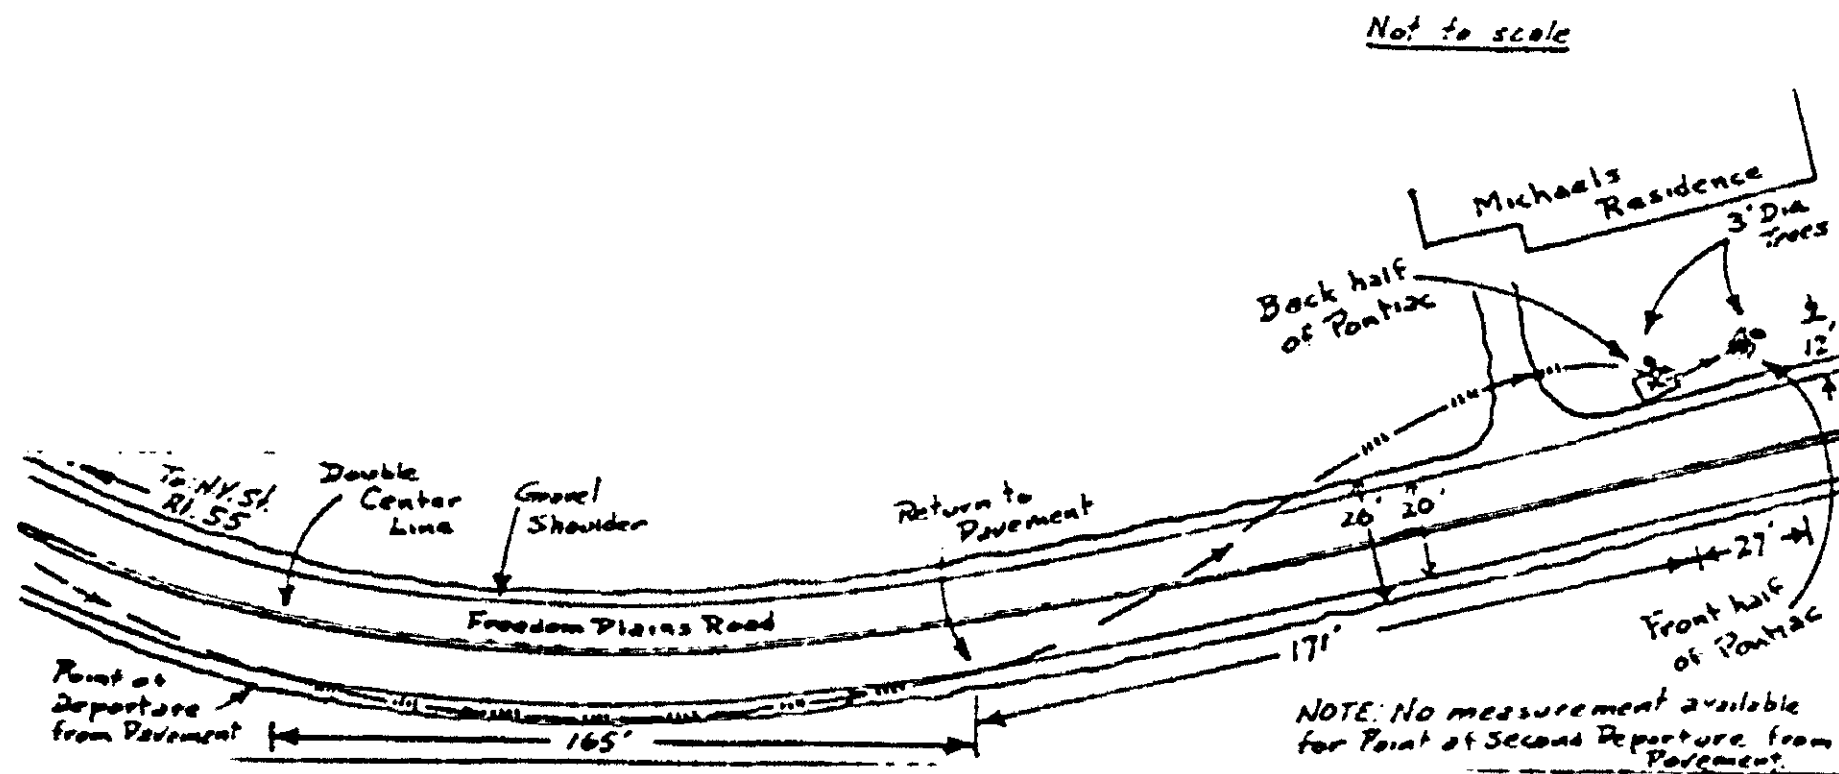
Figure 1

The group traveled north along Freedom Plains Road in the driver's 1967 Pontiac LeMans. At 12:30 p.m., when the car was .4 miles south of LaGrange, the driver failed to negotiate a left-hand curve. (See figure 1.)
